Winslow Farm Community Association Pond Improvement Simplified Overview

Current Status

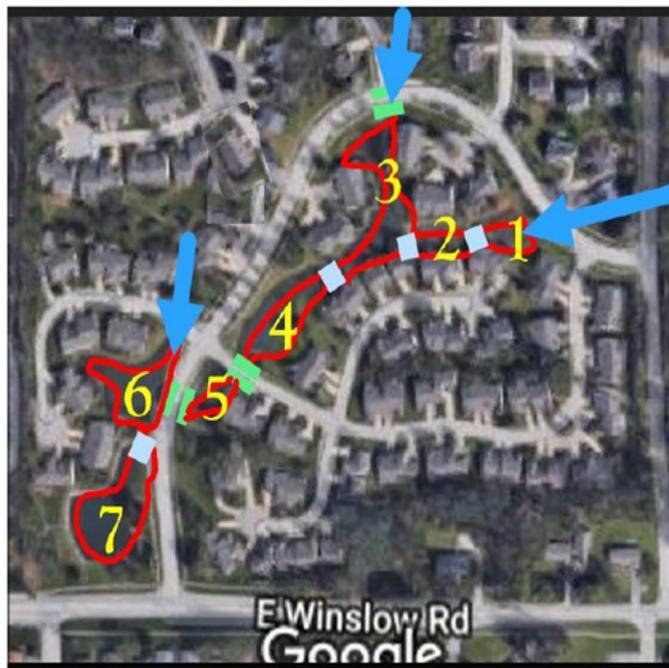
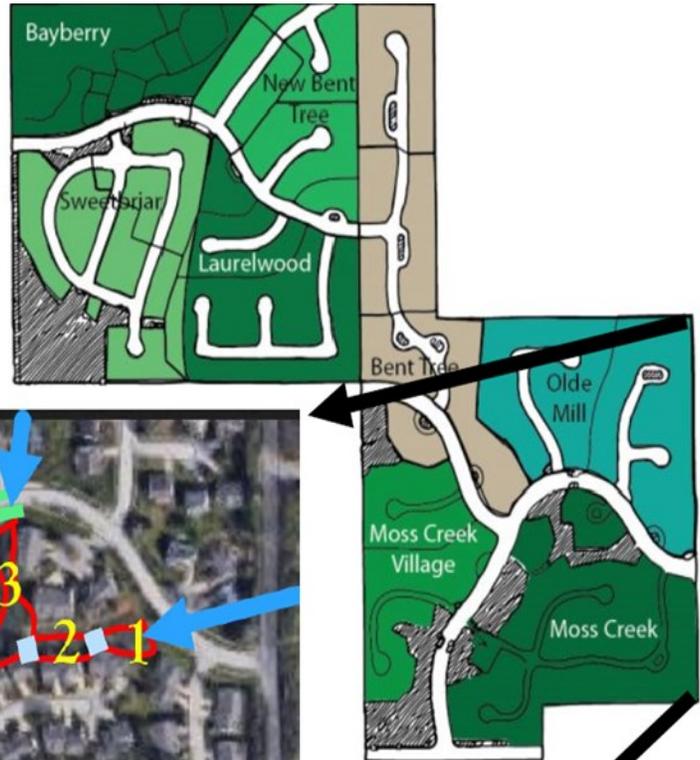
The WFCAs Ponds are numbered 1-7

- P1 is located closest to S Highland Ave.
- P7 is located closest to E. Winslow Rd.
- The arrows donate the major entry point for waterflow
- The double rectangles are bridges
- Single squares are weirs that serve as spillways
- Not shown: An inlet at the north end of P3 has already been filled in to allow for better waterflow.

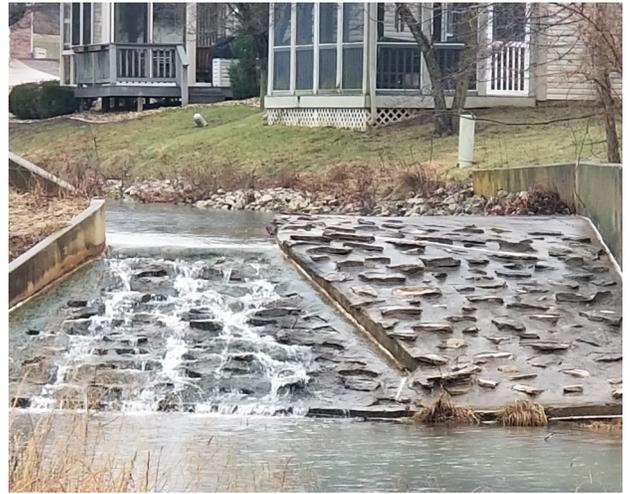
- ◆ The topography of the area has the water flowing from the highest level at pond #1 to the southwest at pond #7.
- ◆ There are weirs between P1-P2, P2-P3 and P3-P4 and a shallow weir between P6-P7. Weirs serve multiple purposes:
 - ◆ They act as a dam to back up the water which pools the water to form the pond.
 - ◆ They channel the water to the lower level in a manner that avoids erosion.
 - ◆ The surrounding retaining walls also serve to prevent erosion as the water is directed through the smaller channel.

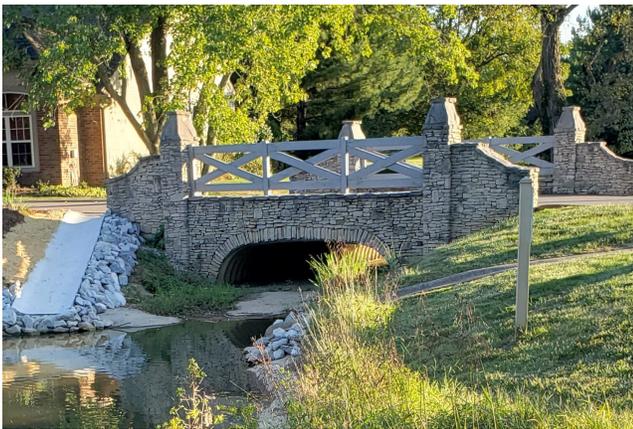
- ◆ There are bridges between P4-P5 and P5-P6. The structure of the bridges includes a concrete structure under the water that also serves as a dam to pool the water to form the pond. During rain, the excess water flows over this structure.

- ◆ A contractor explained that if we do the stream channel option, the concrete structure under the bridge at P4-P5, would always cause some water to pool in what is now pond #4. To prevent the muddy mess much like what has already been experienced in the north end of pond #3, special attention would be required. He went on to explain that the option to remove this concrete structure would require first removing the bridge, reforming the concrete structure, and then replacing the bridge. This would be a very expensive project.

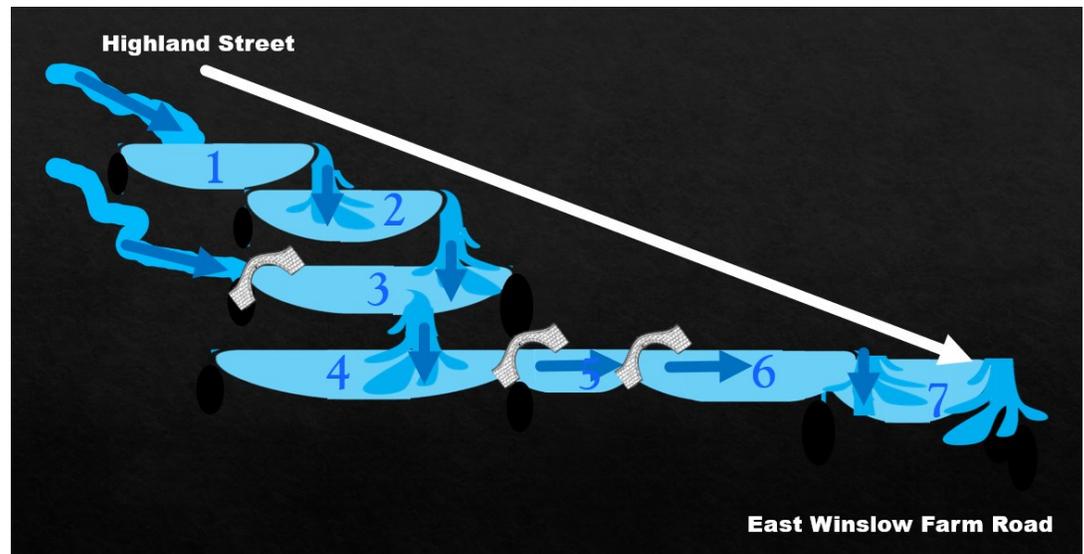
A simplified diagram of how the water flows with the change in elevation

- ◆ There is a definite change in elevation between pond #1 flowing through #2 and #3.
- ◆ However, ponds #4, #5 and #6 all lie on the same plane.

- ⇒ Since there is a change in elevation at the north end, a channel can be designed to create an adequate water flow. But considering the amount of money that has recently been spent to restore ponds #1 and #2 it has NOT been recommended that more money be spent to change either of them to a stream channel.

- ⇒ With the concrete structure under the 4-5 bridge and the absence of a change in elevation, water will pool and create a wetland in #4, #5 and #6. The cost to design an adequate change in elevation is prohibitive. It has NOT been recommended to change P#5, P6 and P7 by both the Conceptual Design and the Davey's report. Accordingly, they will remain as their current configuration of ponds regardless of the final decision for the pond improvement project.

- ⇒ The change in elevation from pond #6 to #7 is very slight, making a stream channel from pond #4 to #7 ineffective.
- ⇒ Therefore, *Mr. Knust's plan did NOT recommend that ponds #5 and #6 be converted to a stream channel. Pond #7 is required as a retention pond* and a change in its configuration is not included in any of the recommendations.
