Reserve Study
for
Winslow Farm Community
Association, Inc.

Reserve Study

Winslow Farm Community Association, Inc.

Account 1137 - Version 03
December 2020

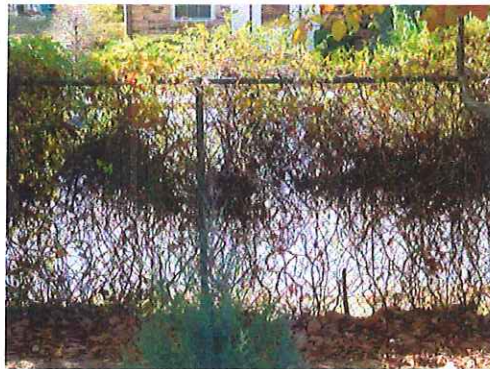
1. Henderson/Graham Chain Link Fence - 2033

There is a six foot high green chain link fence that runs east to west along Graham Drive for a length of 1,296 feet. The fence appears to be in generally good condition. Repairs and maintenance should come from the annual operating account.

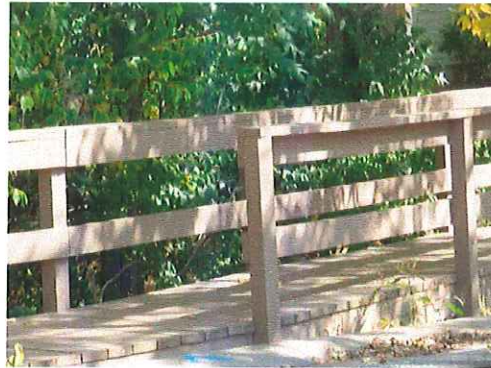
The wooden walkway is 4' wide and 67' in length with two 3' high side rails.

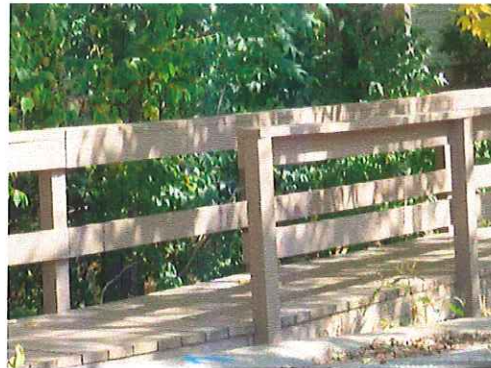
The wooden walkway is 4' wide and 76' in length with two 3' high side rails.

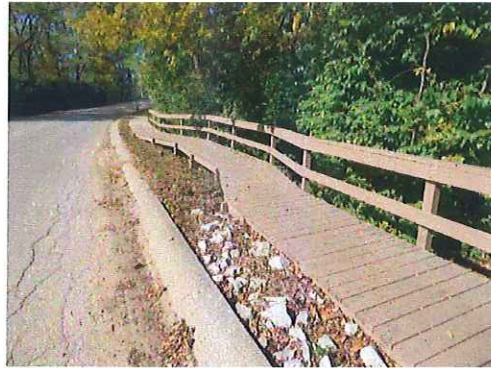
The wooden walkway is 4' wide and 210' in length with two 3' high side rails. One side rail is 210' and the second is 160'.

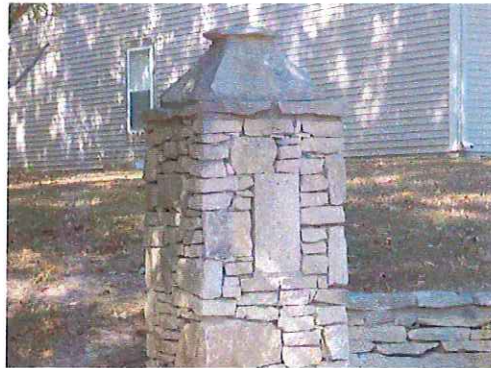
The Bent Tree Entrance is composed of a stacked stone pillar 2' x 2' x 5' high with a concrete cap. Additionally, there is a 3' high stacked stone wall that runs 150' and connects the Bent Tree Entrance Sign with the Olde Mill Entrance Sign (#24). The cost of the stone wall is split between this reserve and the Olde Mill Entrance Sign reserve #24.

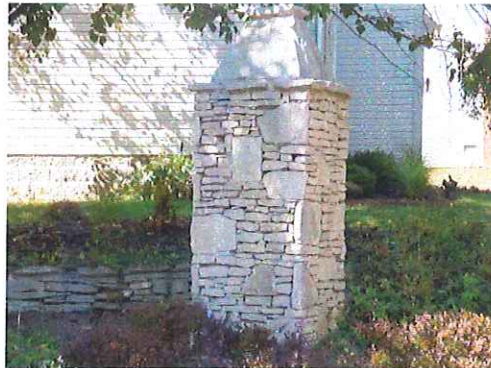
The Olde Mill Entrance is composed of a stacked stone pillar 2' x 2' x 5' high with a concrete cap. Additionally, there is a 3' high stacked stone wall that runs 150' and connects the Bent Tree Entrance Sign with this Olde Mill Entrance Sign. The cost of the stone wall is split between this reserve and the Bent Tree Entrance Sign reserve #22.

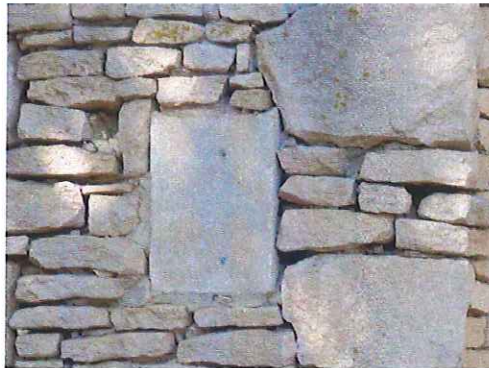
The Olde Mill Entrance is composed of a stacked stone pillar 2' x 2' x 5' high with a concrete cap. Additionally, there is a 3' high stacked stone wall that runs 85' in length.

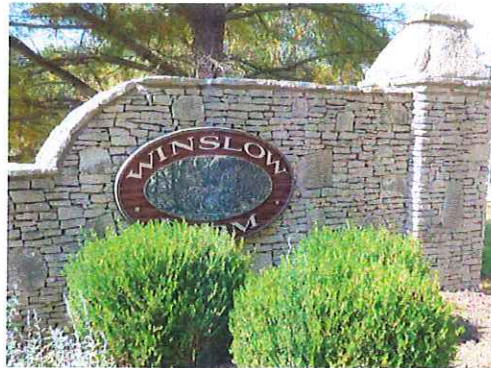
The Highland Entrance is comprised of a stacked stone pillar 2' x 2' x 6' (h) with a concrete cap. Additionally there is a stacked stone wall 15' in length with an average height of 6'. There is an engraved painted sign 5 1/2' x 3 1/2'.

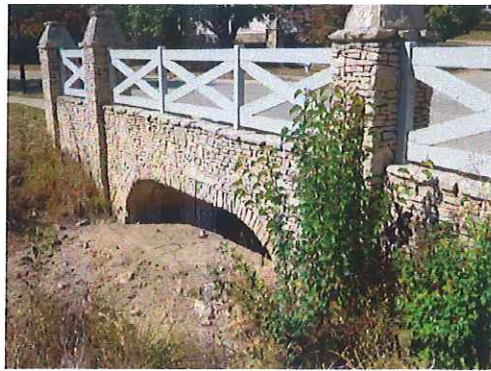
The Olde Mill Bridge is comprised of two identical structures. Each structure has four stacked stone pillars approximately 12' high with an 8' high stacked stone wall 33' in length. Additionally there is a wooden fence 3' high by 33' in length. This reserve funds the eventual replacement of the structure.

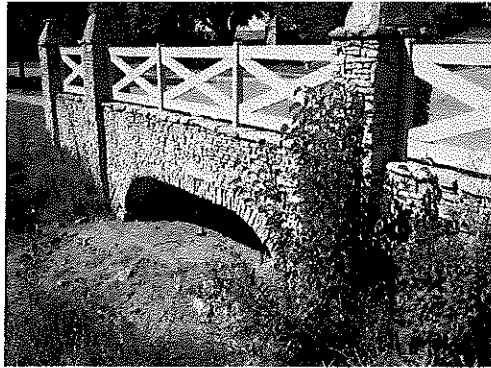
The Olde Mill Bridge is comprised of two identical structures. Each structure has four stacked stone pillars approximately 12' high with an 8' high stacked stone wall 33' in length. Additionally there is a wooden fence 3' high by 33' in length. This reserve funds the eventual replacement of the structure.

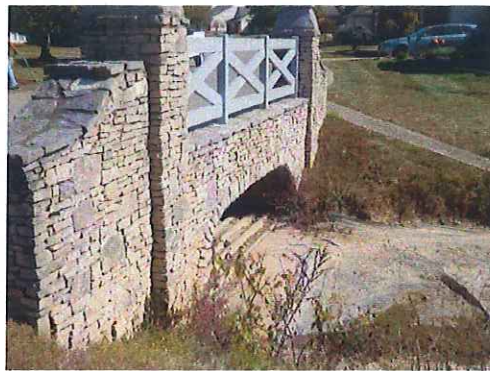
The Moss Creek Bridge is constructed of two identical structures. Each has two stacked stone columns with concrete tops 12' high connected by stacked stone walls with an average height of 8' and a length of 26'. There are wooden railings 3' high by 26' in length. To the outside of the columns are stacked stone walls with limestone caps that are approximately 10' in height and 8' long. This reserve funds the eventual replacement of the structure. This reserve funds periodic repairs to the structure.

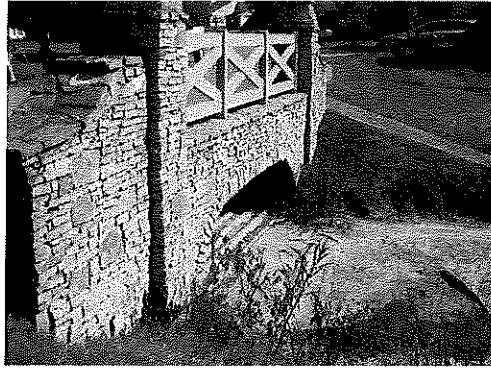
The Moss Creek Bridge is constructed of two identical structures. Each has two stacked stone columns with concrete tops 12' high connected by stacked stone walls with an average height of 8' and a length of 26'. There are wooden railings 3' high by 26' in length. To the outside of the columns are stacked stone walls with limestone caps that are approximately 10' in height and 8' long. This reserve funds the eventual replacement of the structure.

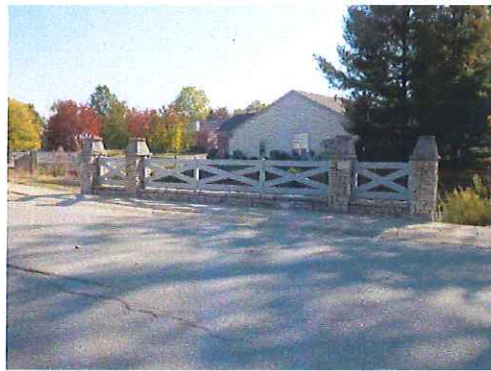
The Olde Mill Bridge is comprised of two identical structures. Each structure has four stacked stone pillars approximately 12' high with an 8' high stacked stone wall 33' in length. Additionally there is a wooden fence 3' high by 33' in length. This reserve funds periodic repairs to the structure.

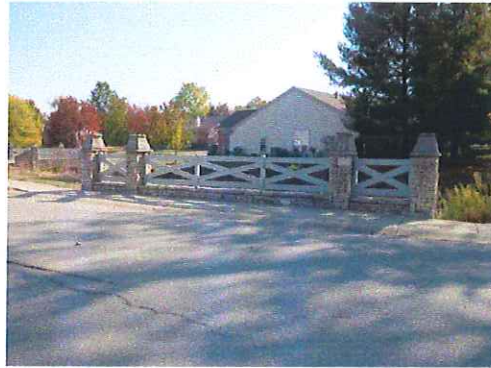
The Olde Mill Bridge is comprised of two identical structures. Each structure has four stacked stone pillars approximately 12' high with an 8' high stacked stone wall 33' in length. Additionally there is a wooden fence 3' high by 33' in length. This reserve funds the eventual replacement of the structure.

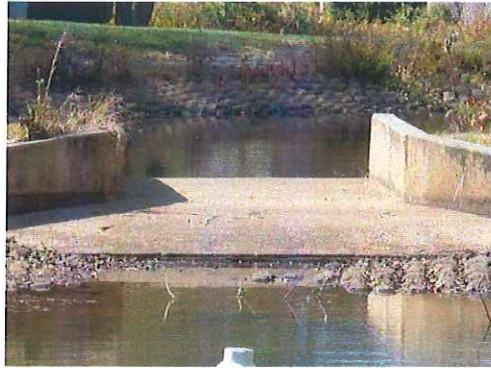
The wier that provides for flow from Pond 1 to Pond 2 has a concrete spillway and concrete sides approximately 3' high. The lifespan of the wier is indeterminate and is likely not to be replaced. We are allocating \$2,000 every 7 years for any concrete repair that would be needed.

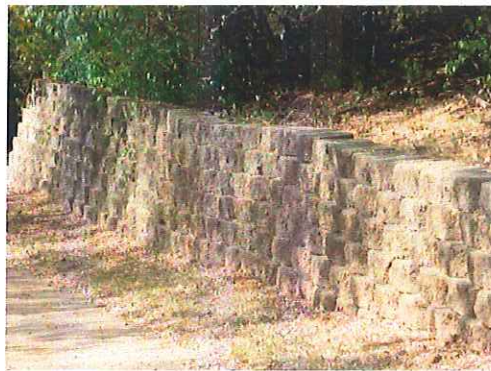
The Wylie Farm Rd. Common Area includes a portion of the interlocking stone retaining wall. We have been informed that most of the wall is homeowner maintained. This reserve funds maintenance and repair to the Association portion of the wall.

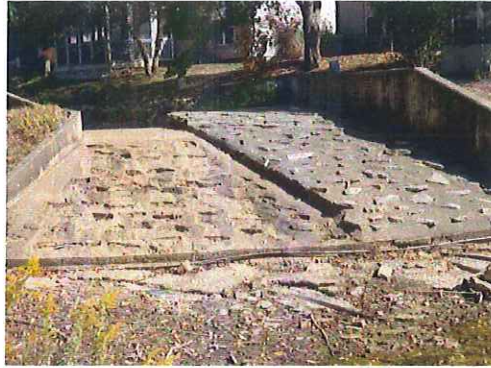
The wier that provides for flow from Pond 3 to Pond 4 has a concrete spillway and concrete sides approximately 3' high. The lifespan of the wier is indeterminate and is likely not to be replaced. We are allocating \$3,000 every 7 years for any concrete repair that would be needed.

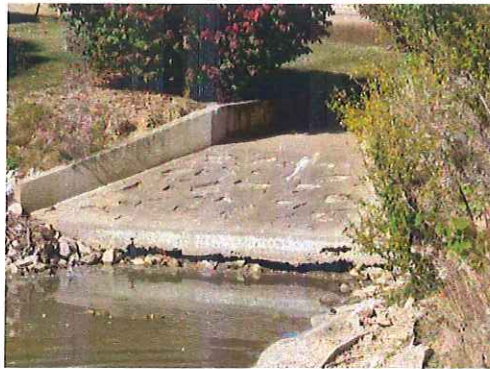
The wier that provides for flow from Pond 6 to Pond 7 has a concrete spillway and concrete sides approximately 3' high. The lifespan of the wier is indeterminate and is likely not to be replaced. We are allocating \$3,000 every 7 years for any concrete repair that would be needed.

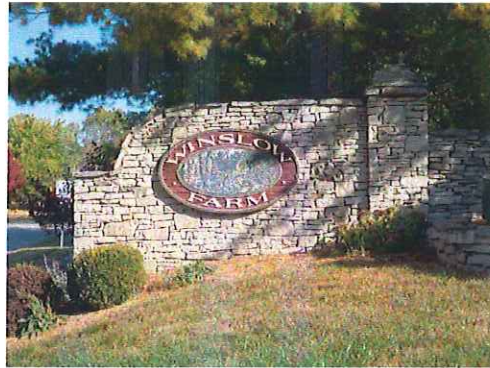
The Winslow Road Entrance has a stacked stone fence with limestone cap that is 6' high and 14' in length. There is an composite engraved and painted sign oval in shape that is 5 1/2' x 3 1/2'

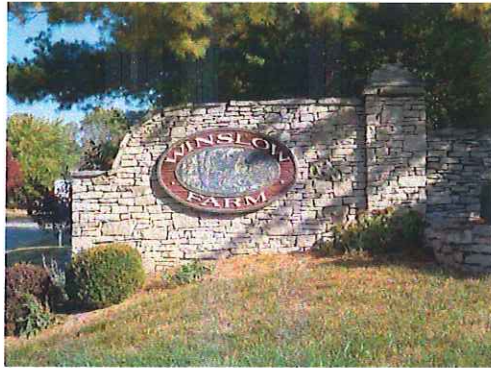
The Winslow Road Entrance has a stacked stone fence with limestone cap that has an average height of 3' and runs for 292' along Winslow Road.

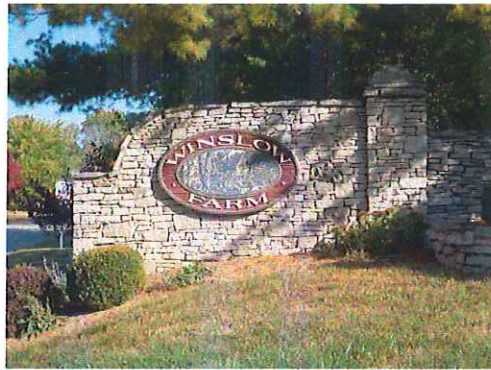
The Winslow Road Entrance has a stacked stone fence with limestone cap that forms a planting bed.

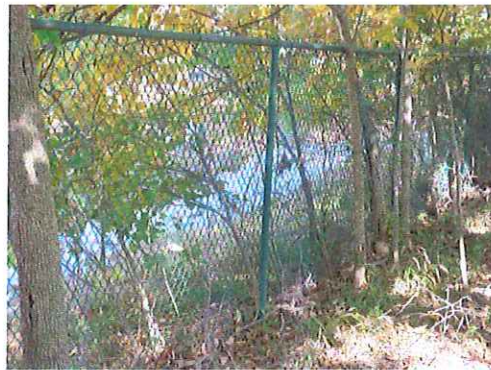
The fence then runs north to south from Graham Drive to Winslow Road for 1,236 feet There is a 6' high green chain link fence that runs south to north from Winslow Road to Graham Drive. The length of the fence is 1,236 feet. The fence appears to be in generally good condition.

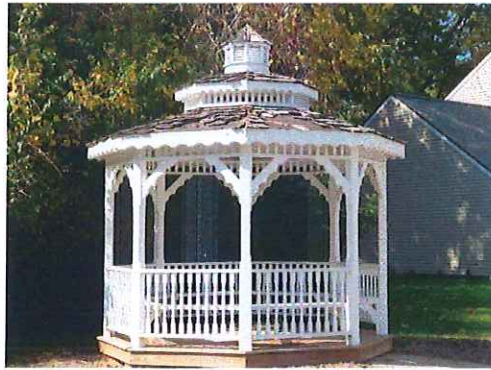
The gazebo is an octagon shaped white wood structure on a 10' diameter concrete slab. There are benches on seven of the sides with decorative wood throughout. The roof is asphalt shingled and supported by eight posts. This reserve funds the eventual replacement of the asset.

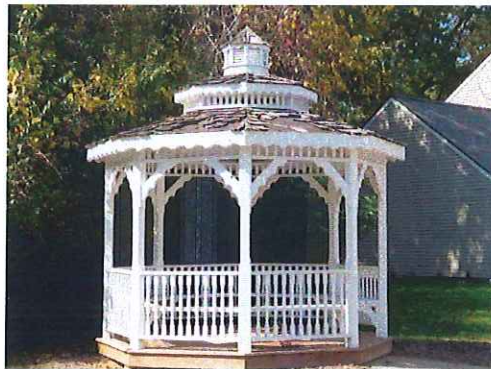
The gazebo is an octagon shaped white wood structure on a 10' diameter concrete slab. There are benches on seven of the sides with decorative wood throughout. The roof is asphalt shingled and supported by eight posts. This reserve funds the periodic refurbishment of the asset including painting, re-roofing and repairs.

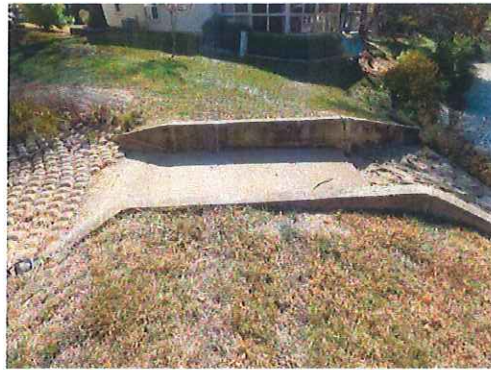
The wier that provides for flow from Pond 2 to Pond 3 has a concrete spillway and concrete sides approximately 2' high. The lifespan of the wier is indeterminate and is likely not to be replaced. We are allocating \$2,000 every 7 years for any concrete repair that would be needed.

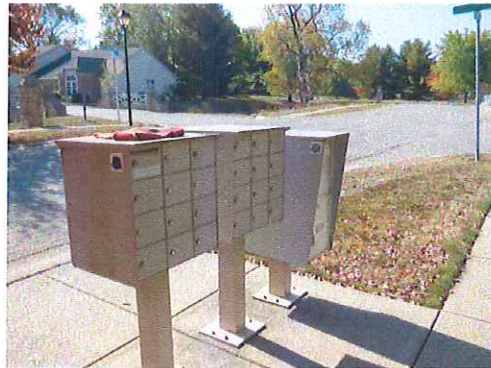
Mailboxes are owned and maintained by the U.S. Postal Service. **There is no cost associated with this reserve and it is noted for informational purposes only.**

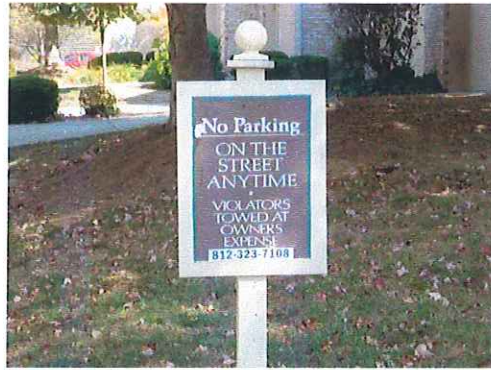
Signage

Miscellaneous signage should be handled through the annual operating account. **There is no funding associated with this reserve.**

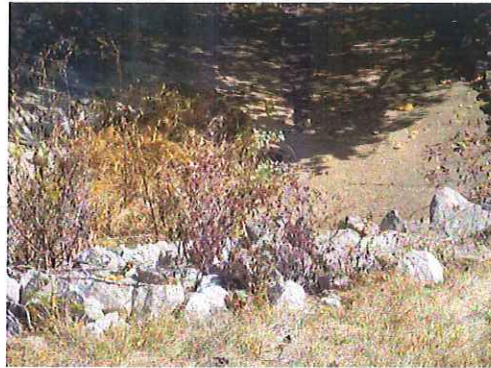
10. Sweetbriar Common Drainage Area

The common drainage area should require little expenditure. Occasional rip rap or maintenance can come from the annual operating account. **This reserve is unfunded.**

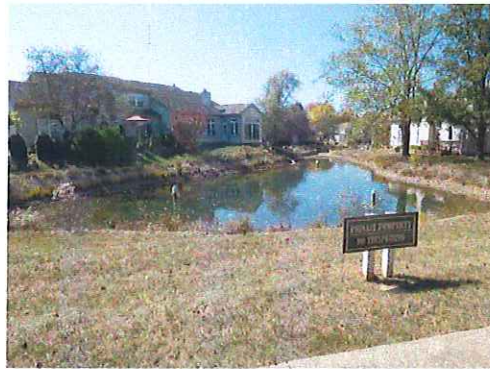
Pond #1 is approximately 4,649 SqFt in area with 307 LnFt of shoreline. The pond was dredged in 2016 at an approximate cost of \$17,000. The pond bank is lined with a concrete edging that should be effective in limiting bank degradation and silting. We have proposed an allowance of \$5,000 every seven years for pond repair and maintenance.

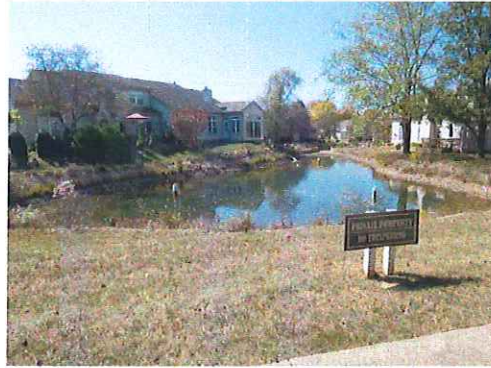
Pond dredging cost estimates and schedules have been provided by the client and are based on the 2019 WFCFA Pond Committee Report (10/22/2019). The client has informed us that all ponds will need to be placed on a 7-year cycle of dredging.

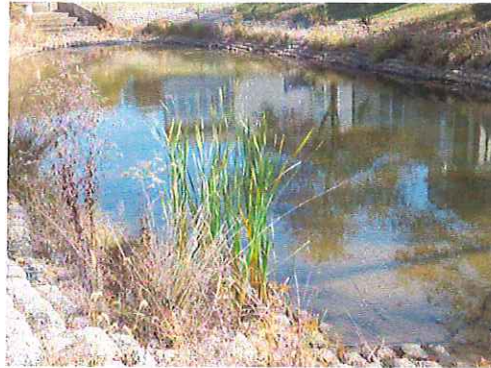
Pond #2 is approximately 2,730 SqFt in area with 254 LnFt of shoreline. The pond was dredged in 2017 at an approximate cost of \$17,000. The pond bank is lined with a concrete edging that should be effective in limiting bank degradation and silting. We have proposed an allowance of \$5,000 every seven years for pond repair and maintenance.

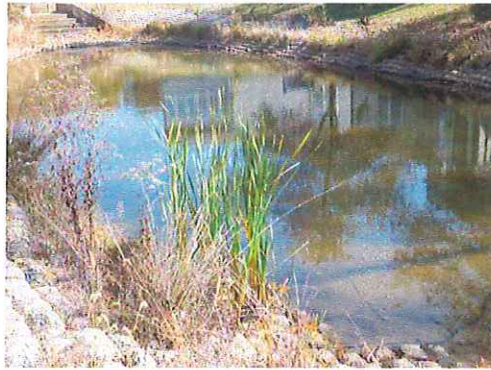
Pond dredging cost estimates and schedules have been provided by the client and are based on the 2019 WFCA Pond Committee Report (10/22/2019). The client has informed us that all ponds will need to be placed on a 7-year cycle of dredging.

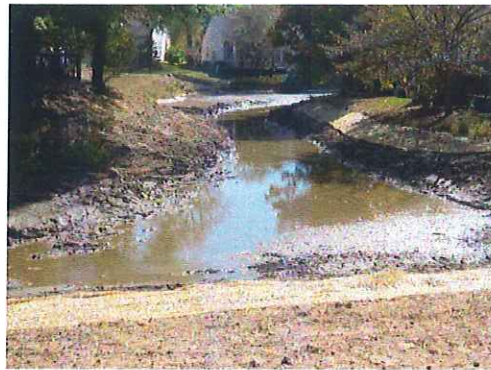
Pond #3 is approximately 11,971 SqFt in area with 896 LnFt of shoreline. The pond is being dredged in 2020. We are anticipating the pond work will be completed and paid for in 2020. Going forward, we have proposed an allowance of \$5,000 every seven years for pond repair and maintenance.

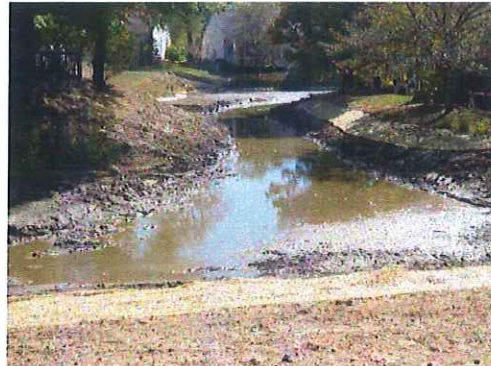
Pond dredging cost estimates and schedules have been provided by the client and are based on the 2019 WFCFA Pond Committee Report (10/22/2019). The client has informed us that all ponds will need to be placed on a 7-year cycle of dredging.

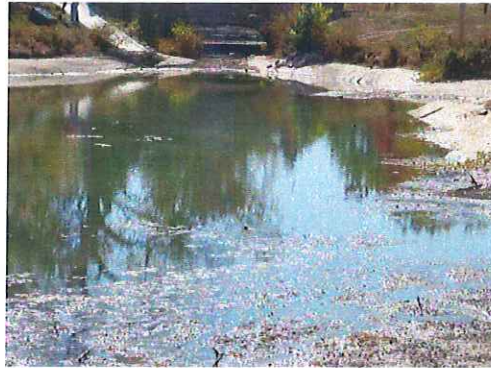
Pond #4 is approximately 10,259 SqFt in area with 542 LnFt of shoreline. Going forward, we have proposed an allowance of \$5,000 every seven years for pond repair and maintenance.

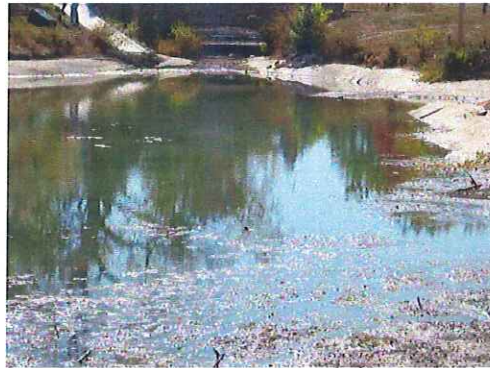
Pond dredging cost estimates and schedules have been provided by the client and are based on the 2019 WFCFA Pond Committee Report (10/22/2019). The client has informed us that all ponds will need to be placed on a 7-year cycle of dredging.

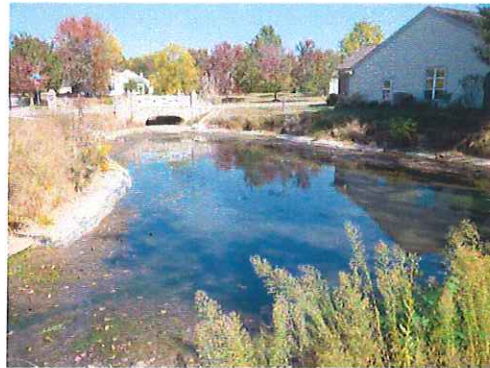
Pond #5 is approximately 4,587 SqFt in area with 267 LnFt of shoreline. Going forward, we have proposed an allowance of \$5,000 every five years for pond repair and maintenance.

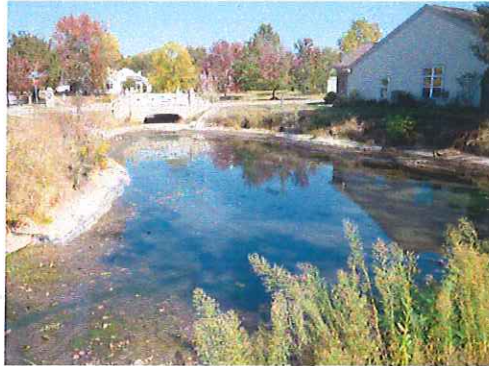
Pond dredging cost estimates and schedules have been provided by the client and are based on the 2019 WFCFA Pond Committee Report (10/22/2019). The client has informed us that all ponds will need to be placed on a 7-year cycle of dredging.

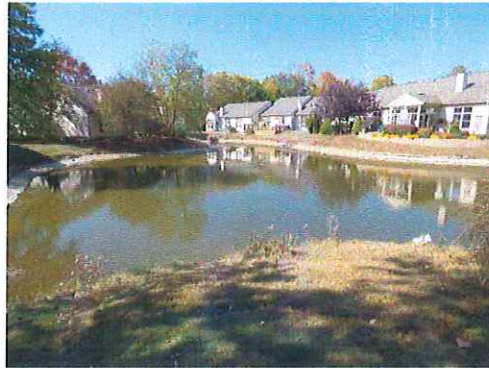
Pond #6 is approximately 14,115 SqFt in area with 645 LnFt of shoreline. Going forward, we have proposed an allowance of \$5,000 every five years for pond repair and maintenance

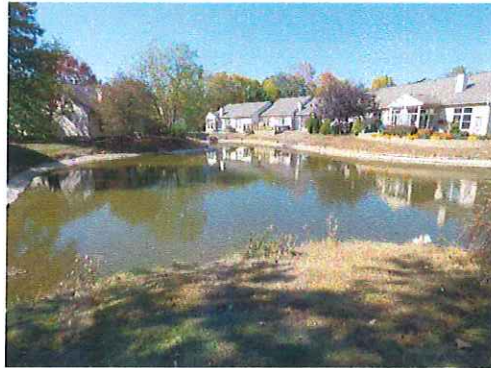
Pond dredging cost estimates and schedules have been provided by the client and are based on the 2019 WFCA Pond Committee Report (10/22/2019). The client has informed us that all ponds will need to be placed on a 7-year cycle of dredging.

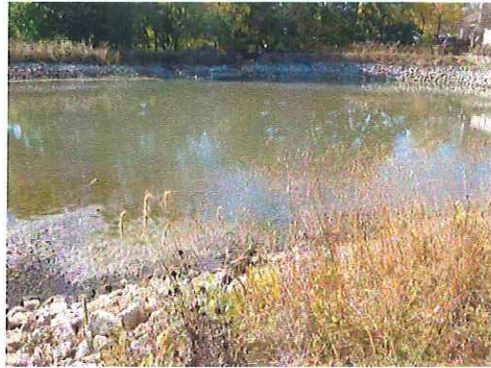
Pond #7 is approximately 15,763 SqFt in area with 653 LnFt of shoreline. Going forward, we have proposed an allowance of \$5,000 every seven years for pond repair and maintenance.

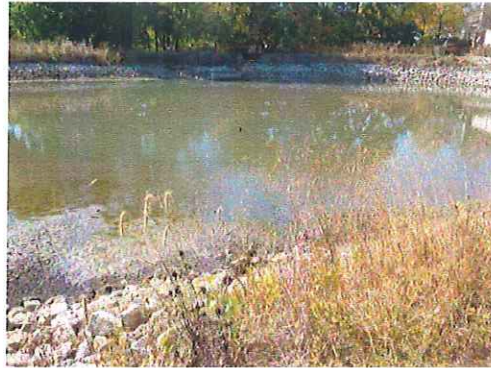
Pond dredging cost estimates and schedules have been provided by the client and are based on the 2019 WFCFA Pond Committee Report (10/22/2019). The client has informed us that all ponds will need to be placed on a 7-year cycle of dredging.

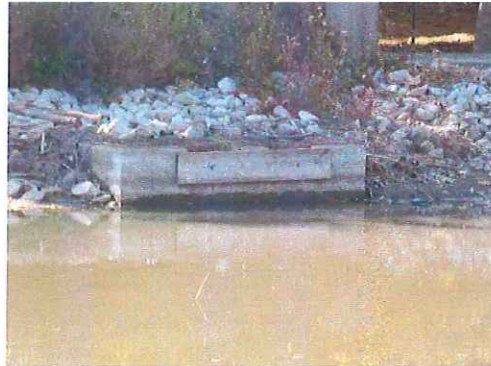
There is a metal grate at the outflow of Pond 7.

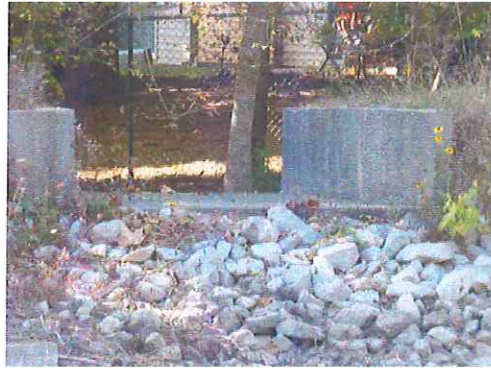
There is a concrete and rock formed dam at the outflow of Pond #7.

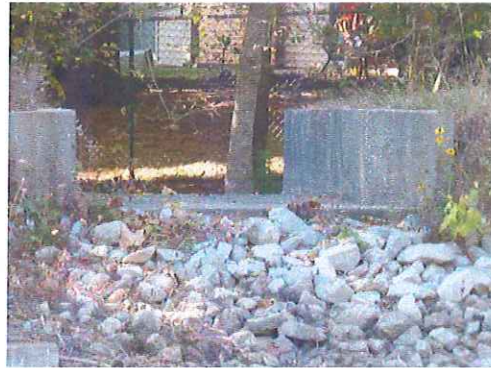
There is a concrete spillway at the outflow of Pond #7.

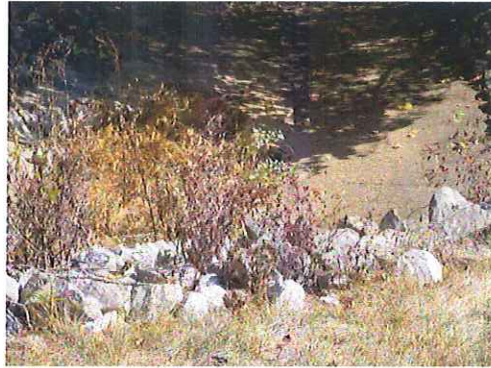
The dry pond should require little expenditure. Occasional rip rap or maintenance can come from the annual operating account.

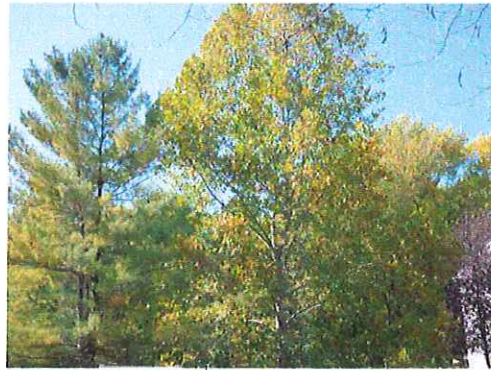
Landscape - 2023

The landscape reserve is for large and occasional projects such as tree removal or trimming.

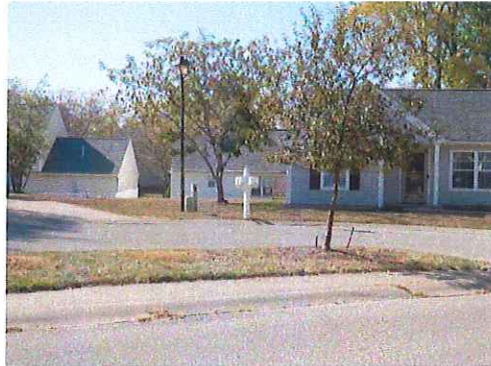
14. Laurelwood Island

The upkeep of the islands is part of the annual operating expenses. Any necessary tree work would come from the general Landscape Reserve. Streets and curbs are municipally maintained and the islands should not require any reserve expenditures. **This reserve is unfunded.**

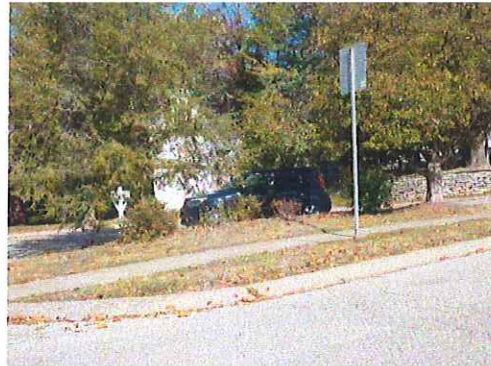
15. Bent Tree Island 1

The upkeep of the islands is part of the annual operating expenses. Any necessary tree work would come from the general Landscape Reserve. Streets and curbs are municipally maintained and the islands should not require any reserve expenditures. **This reserve is unfunded.**

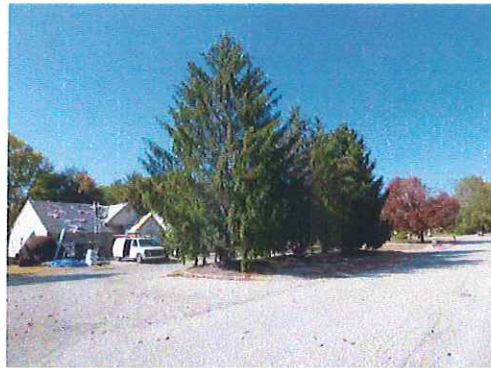
16. Bent Tree Island 2

The upkeep of the islands is part of the annual operating expenses. Any necessary tree work would come from the general Landscape Reserve. Streets and curbs are municipally maintained and the islands should not require any reserve expenditures. **This reserve is unfunded.**

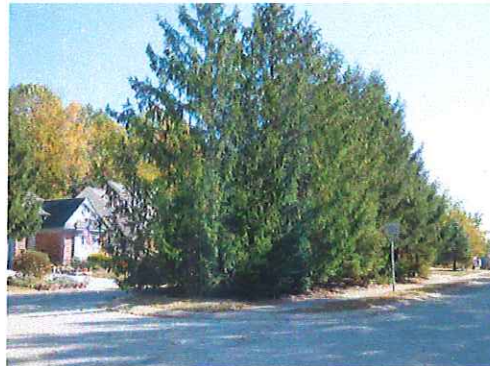
17. Bent Tree Island 3

The upkeep of the islands is part of the annual operating expenses. Any necessary tree work would come from the general Landscape Reserve. Streets and curbs are municipally maintained and the islands should not require any reserve expenditures. **This reserve is unfunded.**

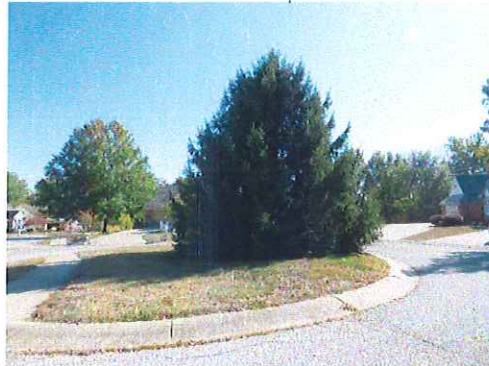
18. Bent Tree Island 4

The upkeep of the islands is part of the annual operating expenses. Any necessary tree work would come from the general Landscape Reserve. Streets and curbs are municipally maintained and the islands should not require any reserve expenditures. **This reserve is unfunded.**

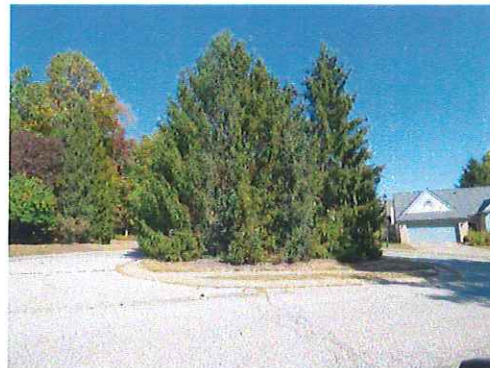
19. Bent Tree Island 5

The upkeep of the islands is part of the annual operating expenses. Any necessary tree work would come from the general Landscape Reserve. Streets and curbs are municipally maintained and the islands should not require any reserve expenditures. **This reserve is unfunded.**

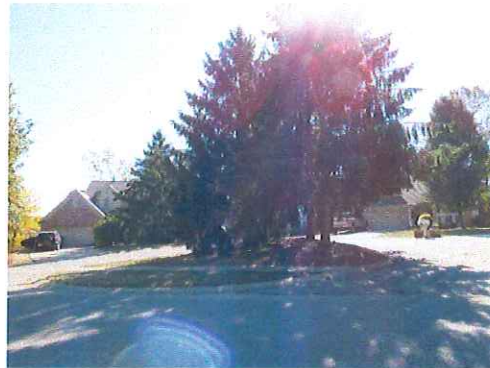
20. Bent Tree Island 6

The upkeep of the islands is part of the annual operating expenses. Any necessary tree work would come from the general Landscape Reserve. Streets and curbs are municipally maintained and the islands should not require any reserve expenditures. **This reserve is unfunded.**

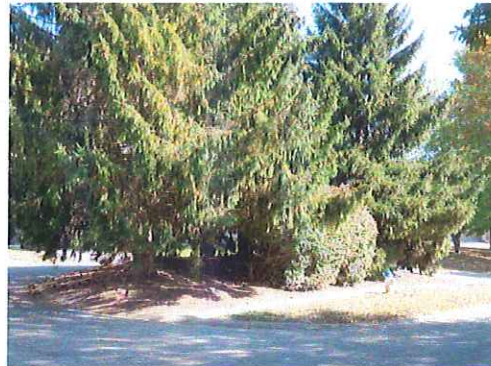
21. Bent Tree Island 7

The upkeep of the islands is part of the annual operating expenses. Any necessary tree work would come from the general Landscape Reserve. Streets and curbs are municipally maintained and the islands should not require any reserve expenditures. **This reserve is unfunded.**

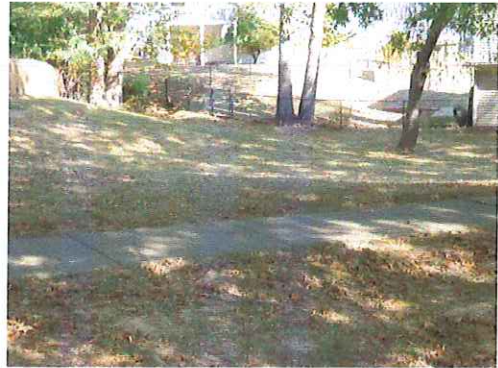
23. Bent Tree/ Hickory Stick Drive Common Area

The upkeep of the Bent Tree/Hickory Stick Drive Common Area is part of the annual operating expenses. Any necessary tree work would come from the general Landscape Reserve. Streets and curbs are municipally maintained and the islands should not require any reserve expenditures. **This reserve is unfunded.**

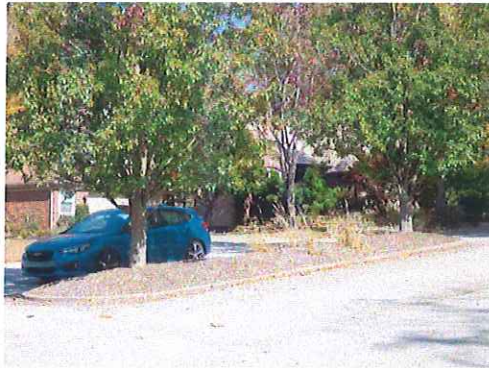
26. Olde Mill Island 1

The upkeep of the islands is part of the annual operating expenses. Any necessary tree work would come from the general Landscape Reserve. Streets and curbs are municipally maintained and the islands should not require any reserve expenditures. **This reserve is unfunded.**

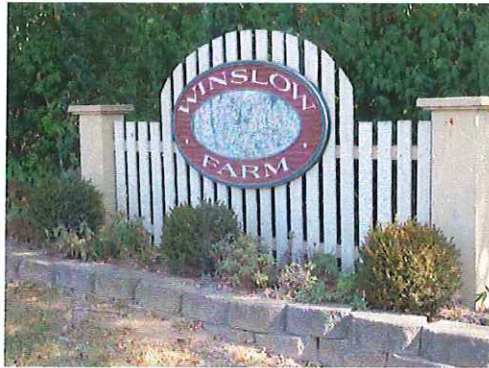
3. Henderson Entrance - 2037

The Henderson Road Entry Monument is a painted wooden fence style structure 12' in length with an average height of 4'. It contains a 5 1/2' x 3 1/2' painted and engraved oval sign.

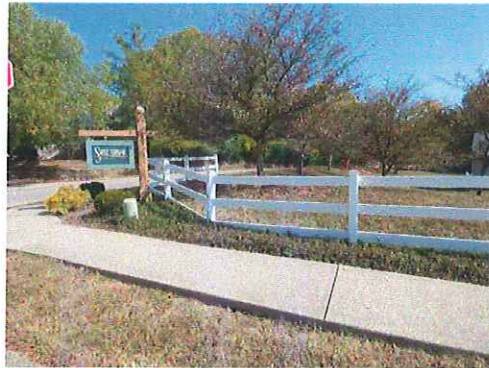
5. Sweetbriar Entrance Eastside - 2033

The Sweetbriar Entrance to the west consists of a composite sign 3 1/2' x 2 1/2', engraved and painted, and mounted to a wooden post 7' 6" in height. Additionally there is a 3 rail white plastic fence 3 1/2' in height and 88' in length.

1 - sign	@	\$350.00	\$350.00
88 - LnFt three rail pvc fence	@	\$22.00	<u>\$1,936.00</u>
		Total =	\$2,286.00

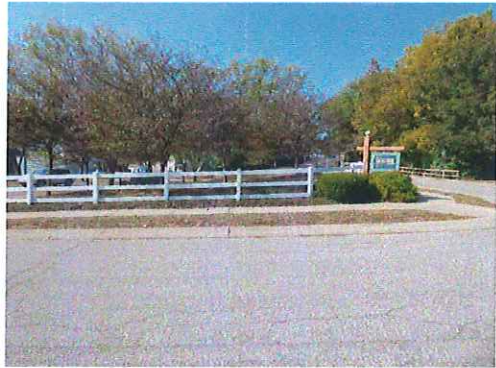
5A. Sweetbriar Entrance Westside - 2033

The Sweetbriar Entrance to the west consists of a composite sign 3 1/2' x 2 1/2', engraved and painted, and mounted to a wooden post 7' 6" in height. Additionally there is a 3 rail white pvc fence 3 1/2' in height and 72' in length.

1 - sign	@	\$350.00	\$350.00
72 - LnFt three rail pvc fence	@	\$22.00	<u>\$1,584.00</u>
		Total =	\$1,934.00

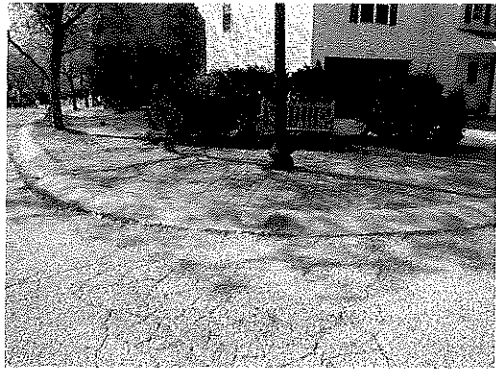
5B. Sweetbriar Entrance Westside - 2032

Also included in the Sweetbriar Entrance are two corners of the intersection both with benches and sidewalk treatment of brick and poured concrete.

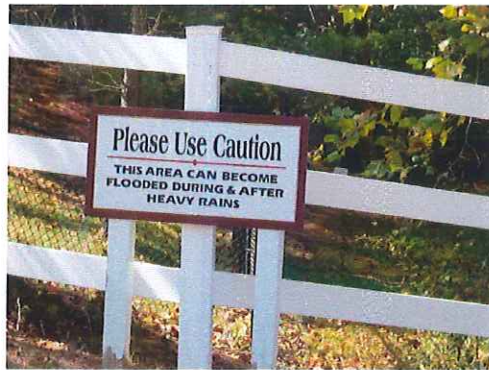
9. Sweetbriar Dry Pond Sign & Fence - 2028

There is a sign and 5' high 3 rail pvc fence protecting the dry pond area.

1 - sign	@	\$250.00	\$250.00
24 - LnFt fence	@	\$30.00	<u>\$720.00</u>
		Total =	\$970.00
