Winslow Farm Community Association Pond Improvement Simplified Overview

Current Status

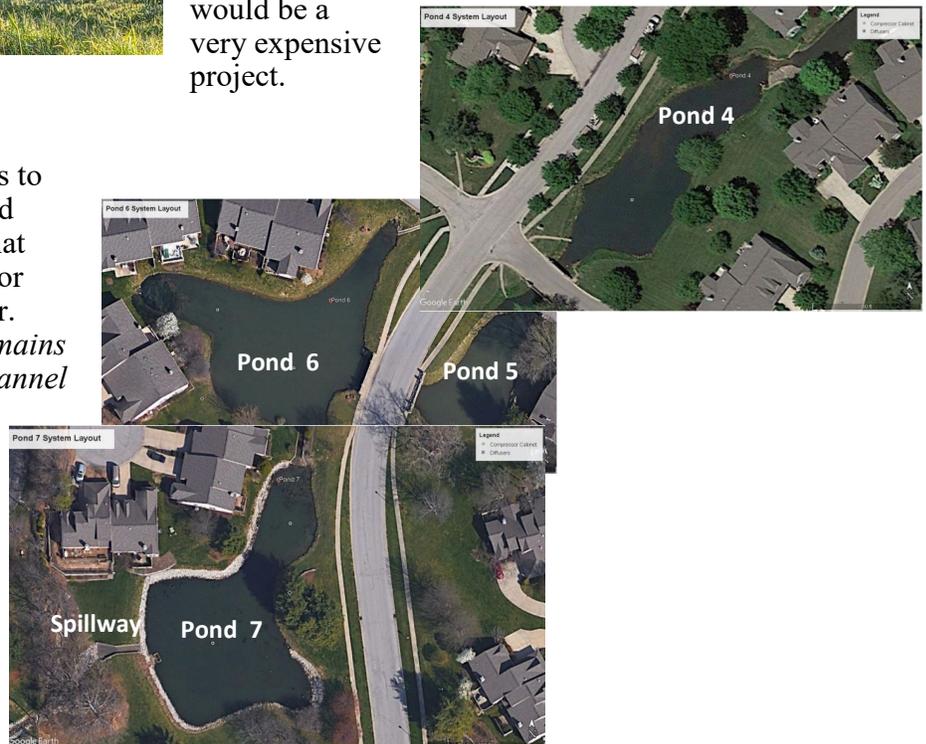
It is important to understand the topography of the area.

- ◆ There is a definite change in elevation between pond #1 flowing through #2 and #3.
- ◆ However, ponds #4, #5 and #6 all lie on the same plane.

- ⇒ With the concrete structure under the 4-5 bridge and the absence of a change in elevation, water will pool and create a wetland in #4, #5 and #6. The cost to design an adequate change in elevation is prohibitive. It has NOT been recommended to change P#5, P6 and P7 by both the Conceptual Design and the Davey's report. Accordingly, they will remain as their current configuration of ponds regardless of the final decision for the pond improvement project.

- ⇒ The change in elevation from pond #6 to #7 is very slight, making a stream channel from pond #4 to #7 ineffective.
- ⇒ Therefore, *Mr. Knust's plan did NOT recommend that ponds #5 and #6 be converted to a stream channel. Pond #7 is required as a retention pond* and a change in its configuration is not included in any of the recommendations.
