Highlights of The Conceptual Design Report submitted by Mr. Andrew Knust, P.E

Winslow Farm Community Association Pond Improvement Simplified Overview

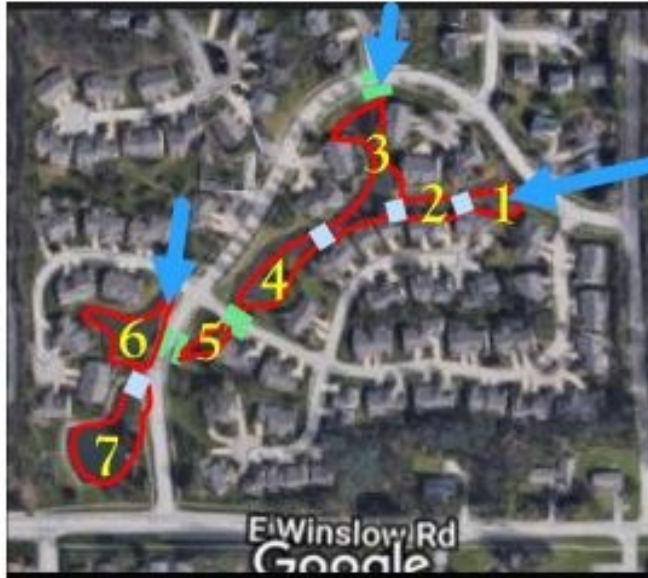
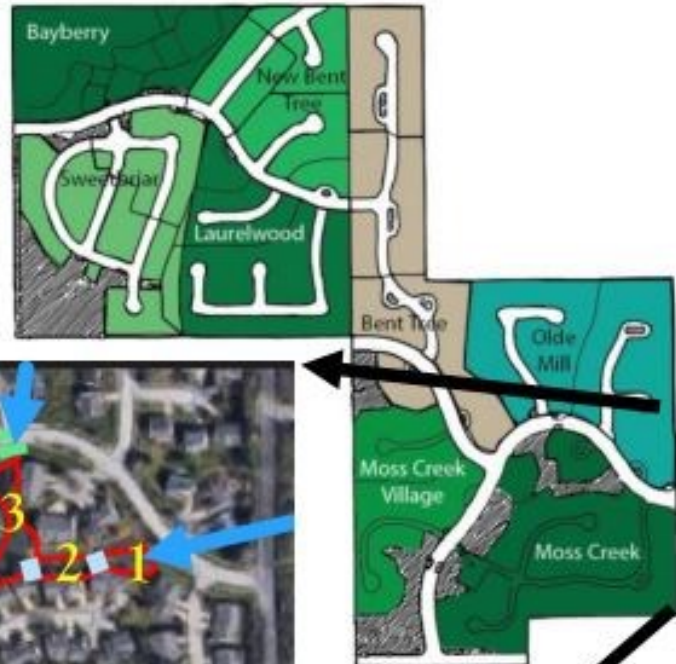
Current Status

The WFCAs Ponds are numbered 1-7

- P1 is located closest to S Highland Ave.
- P7 is located closest to E. Winslow Rd.
- The arrows donate the major entry point for waterflow
- The double rectangles are bridges
- Single squares are weirs that serve as spillways
- Not shown: An inlet at the north end of P3 has already been filled in to allow for better waterflow.

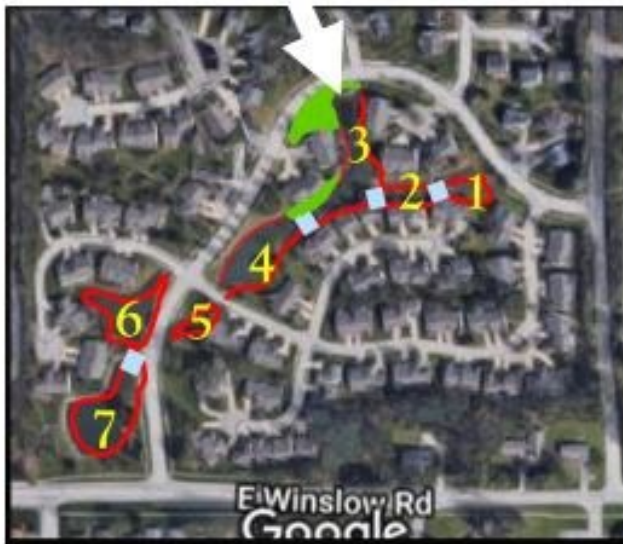
PROPOSED SCENARIO #1 POND REWAL

- Add sediment forebay north end of P3 to capture sediment
- Reinforce banks that have eroded in P3
- Dredge and deepen P3, install new liner
- Dredge & reline ponds 4-7, reinforce banks as needed
- Configuration remains as current

- The construction cost opinion for Scenario 1 assumes that all the ponds would be deepened and have a new liner installed.
- Specifically Ponds 3, 4, 5, 6, & 7:

- Drain down and remove sediment by mechanical dredging.
 - Remove liner and excavate to beneath the pond liner, increasing depth by 2-5 feet.
 - Stabilize shorelines with geofabric-wrapped soil “shelves” stabilized with soil and plantings.

- Install aeration fountains where electrical service is available.
 - Wherever Ponds are deepened and new liners installed, consider diffused aeration system in lieu of fountains.

- Restore impacted access areas.
- Additional work at Pond 3:
 - Install sediment forebay at north end of Pond 3, lined with pond liner only.
 - Construct stabilized access area for annual maintenance by vactor truck.

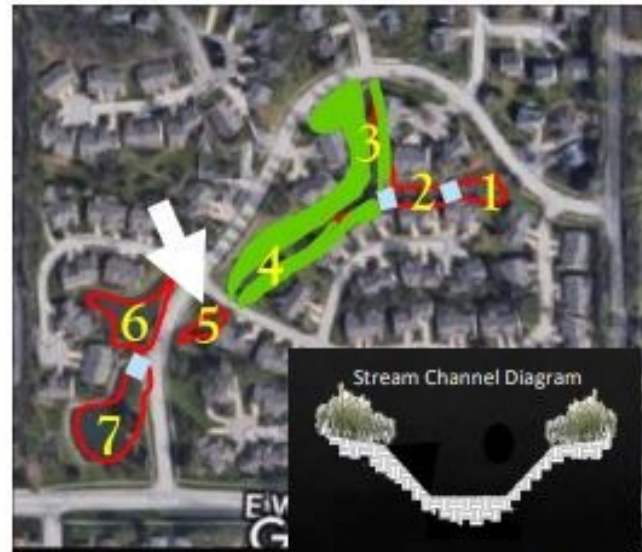
PROPOSED SCENARIO #2: STREAM CHANNEL

- Pond 3/4: Reconfigure into a channel bed and install liner
- Remove weir between P3 & P4, replace with retaining walls
- Install sediment forebay in P5
- Dredge & reline ponds 5-7, reinforce banks as needed
- Install erosion control landscaping P3 and rain garden in P4.

Note that Pond 3 has been eliminated from the Conceptual Design model, replaced by an open channel to Pond 4. Even though Pond 4 will be redesigned to appear as a stream channel, it is still represented as a pond in the model because water would continue to pond up behind the culvert at Moss Creek Drive during large flood events, providing some storage of floodwaters in the former location of Pond 4. During smaller storm events, however, stream flow would be contained within the constructed stream channel with minimal overbank flow. (Note that possibly with the exception of drought, there will be some standing water in what is now considered to be pond #4.)

- The concrete spillway structure (*weir*) at the south end of Pond 3 would be removed and replaced with a 1.4' high grade control constructed with natural boulders

- A restored natural stream channel would be created through the existing locations of Pond 3 and Pond 4.
- Pond 5 would be dredged and reconstructed to serve as a sediment forebay, protecting Ponds 6 and 7 from excessive sedimentation.
